Corrosion

devoted entirely to
CORROSION
research and control

Published Monthly as its official journal, by the National Association of Corrosion Engineers, Inc., at Houston, Texas, U. S. A., as a permanent record of progress in corrosion control.

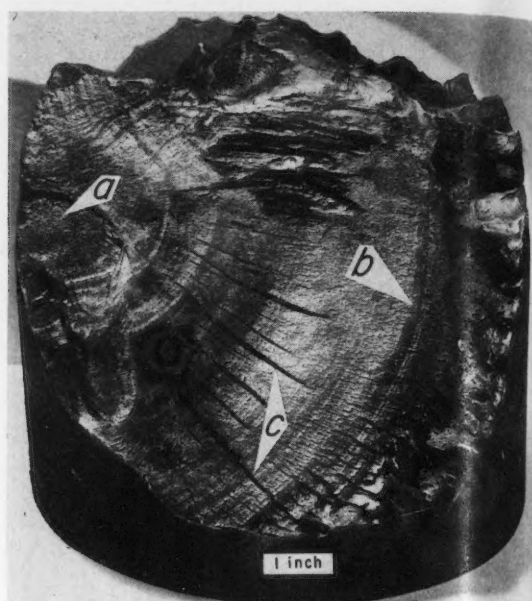
Figure 5—Macrofractograph of the outboard fragment. Details of the fracture history are revealed by the *a* focal, *b* peripheral, and *c* conjunctural markings.

Approximately perpendicular to the peripheral traces, *conjunctural* markings often appear as indicated at "c." These result from the meeting of local fracture units, which often extend fingerlike ahead of the periphery, sometimes even developing as isolated areas of adhesion within the solid in advance of the fracture front. When
